# Manhole Inspection Summary

Manhole # S51K\_\_034MH

Insp Date: **3/28/08 11:01 AM**

**Location** Address: **rear 2714 faith ave**

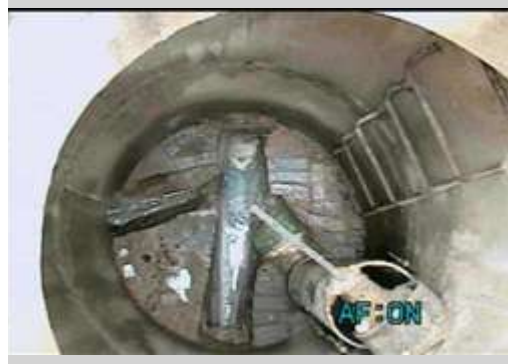
Top View

end of alley

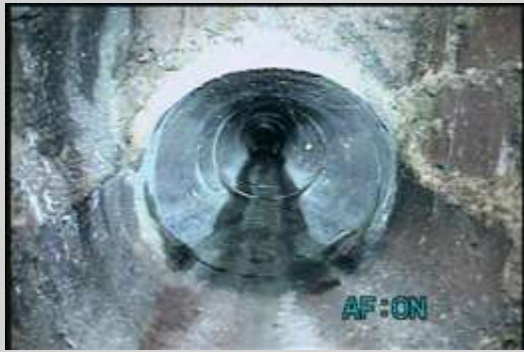
Pipe In @ 6 O'Clock

Pipe Height: 0 (in.) Direct

Pipe Material: **Clay** ☐ Pipe Lined

Invert Depth: **9.66** (ft.) Flow Characteristics: **Slow**

Deposits: ☒ None ☐ Mud ☐ Sludge ☐ Debris ☐ Grease

Infiltration: **None** Pipe Seal Cond: **Unknown**

Connects To: **Dead End**

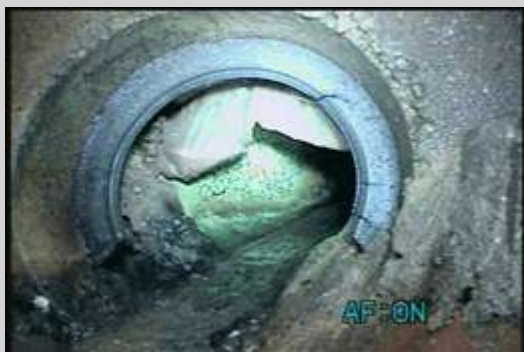
Pipe In @ 9 O'Clock

Pipe Height: 0 (in.) Direct

Pipe Material: **Clay** ☐ Pipe Lined

Infiltration: **None** Pipe Seal Cond: **Unknown**
